A Water Quality and Contaminant Source Assessment of Arbuckle Creek in Fayette County, West Virginia

**A WATER QUALITY AND CONTAMINANT SOURCE ASSESSMENT OF ARBUCKLE
CREEK IN FAYETTE COUNTY, WEST VIRGINIA**

A thesis submitted to
the Graduate College of
Marshall University
In partial fulfillment of
the requirements for the degree of
Master of Science

In
Environmental Science

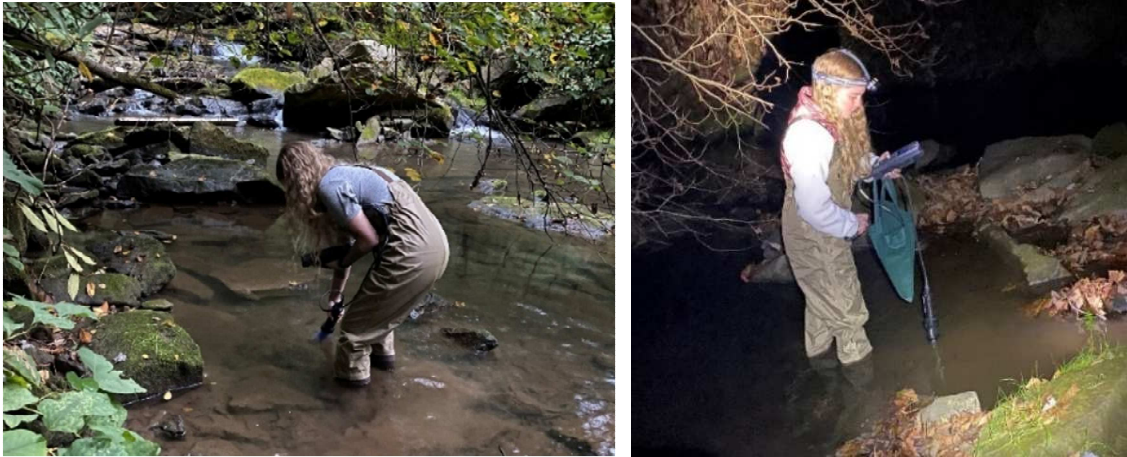
Figures 10 and 11. Biomonitors sampling being done in Arbuckle Creek; Images produced by MelQuan Green and Sarah Simonton.

protecting it can be implemented, as seen through the use of the water quality meter in **Figures 10 and 11**. For these reasons, using macroinvertebrates, water parameters, and benthic algae to study stream health is appropriate.

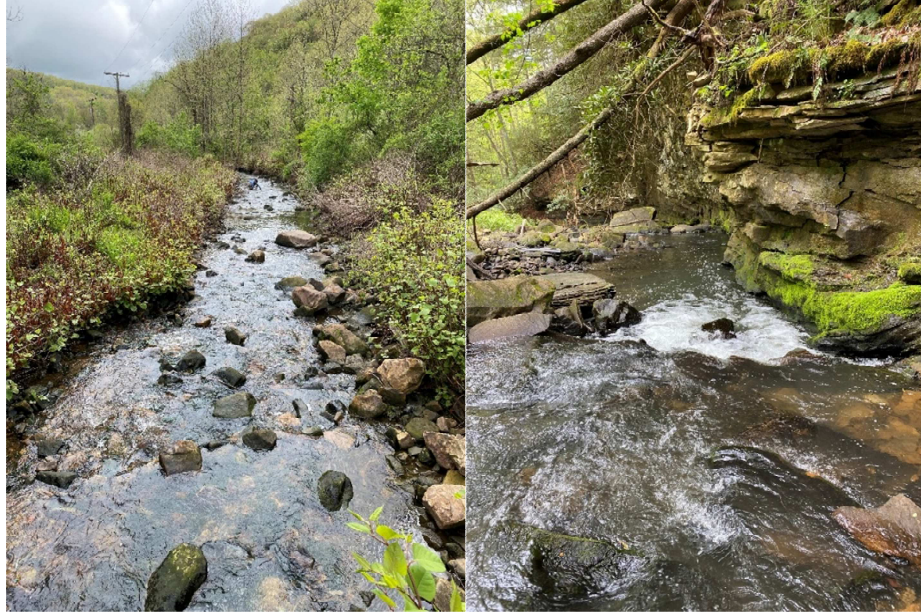
Figures 16 and 17. Showcasing the difference between Site One's habitat and Site Three's habitat; Images produced by Sarah Simonton.

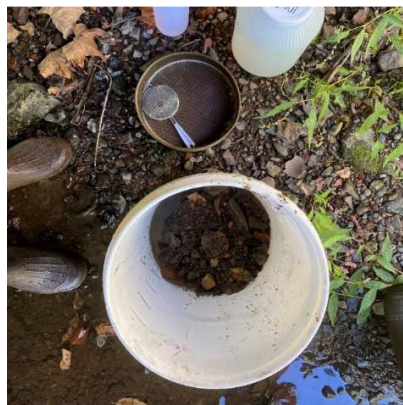
Figure 18. Sampling equipment for macroinvertebrates; Image produced by Sarah Simonton.

While hypothesizing that the benthic macroinvertebrate community will show impairment due to the past implications of the Shaffer Equipment Site and mining in the area, surveys were performed. In order to assess the stream health of Arbuckle Creek, the benthic macroinvertebrate community was assessed at two separate times of the year, the first during May 2021 and the second during September 2021. This was in order to assess the variability in species and to see if the conditions for the other parameters, in addition to the macroinvertebrates, such as water quality and benthic algae, changed over time. For the analysis of the benthic community, the WVDEP Watershed Assessment Branch Field Sampling Standard Operating Procedures were used. Using this methodology, 6 surveys were completed overall at 3 separate sites. These sites were designated as Upstream Site One, Middle Point Site Two, and Rocklick Trail Site Three. After a pronounced riffle was established as a site point for the surveys, four 0.25m² kicks were completed. With each kick, a bucket catching the rocks and other debris was present and used for collecting, as seen below in **Figure 18**.

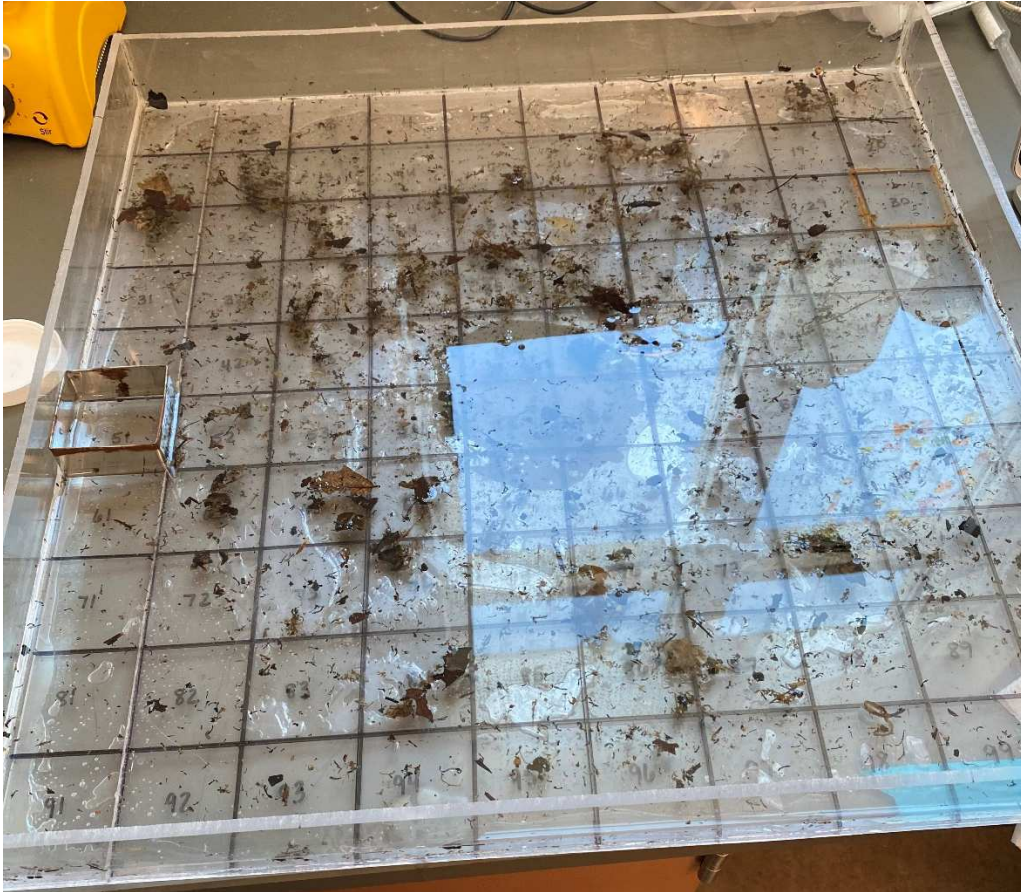
Figure 19. Board for assessing bug species; Image produced by Sarah Simonton.

Next, the debris was filtered, rinsed, and placed in a labeled jar with an ethanol solution. In the lab, the WAB Field Sampling Standard Operating Procedure was followed for 200 (+40) organisms. This included random sampling using a grid pattern to identify the benthic macroinvertebrates down to taxonomic family using <https://www.macroinvertebrates.org/> to actually identify the insects and a board, such as the one in **Figure 19**.
