CABELL COUNTY
ARCHITECTURAL
GUIDE

TOUR G
BARBOURSVILLE

Tour G — Barboursville

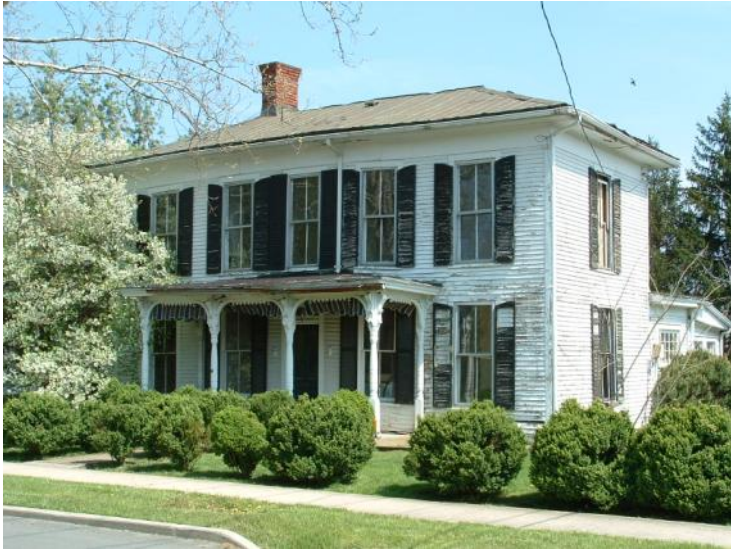
1 John Thornburg House

The window sash and surrounds, entrance doors, and one story porch are all typical of later 19th Century details. The L shaped two story structure is covered by a gable roof with boxed eaves and a wide plain fascia. The exterior consist of original clapboard. The single level roof of the front porch is supported by molded columns above which is situated a dentilian fascia. There exists an even distribution and proportion in the horizontal placement of two over two sash light windows on both levels. All windows contain original wooden surrounds with wooden sills and lintels. The front door is covered by an etched glass transom. (4)

Because of its authentic quality and fine design, the building deserves an urgent preservation course of action.

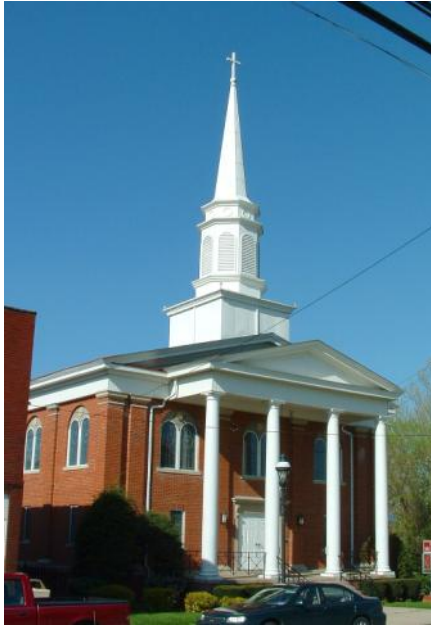
2 Methodist Episcopal Church

As several American churches (See, Tour A, No. 37, Huntington Downtown Section), it consists of a rectangular hall, front gabled and with a low pitched roof, with an imposing full height classical porch, detached from the main façade.

A wrap-around flat entablature, with a simple cornice is supported by red brick pilasters at the sides of the aisle, and pairs of pilasters at its corners. Windows are regularly spaced all around the second floor, and are composed with two round arched glass panels, with a medallion in their spandrels. A traditional square tower stands in the front, supporting a smaller octagonal belfry and a pointed, tall spire with a cross finial. Above the doorway is a cornice supported by consoles or brackets, enriched with acanthus leaves.

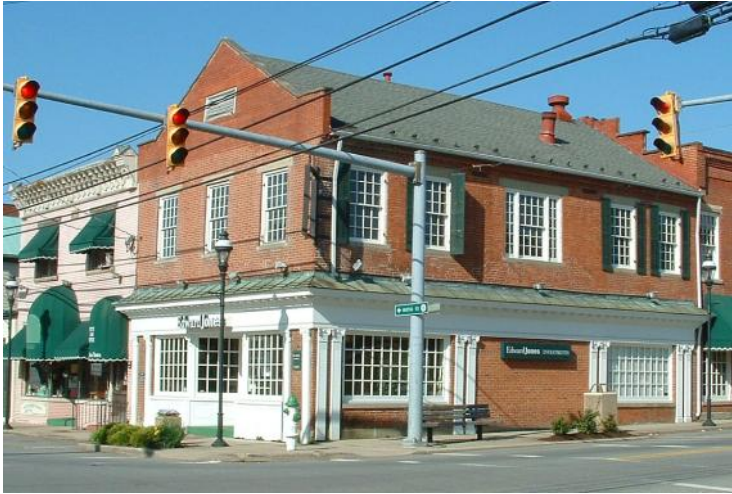
3 Miller Thornburg Store

A masonry block of two stories, covered by a side gable roof, built with locally manufactured bricks, this edifice is now the result of several renovations.

The upper part of it seems to be mostly close to its original shape. The gable side has a stepped parapet, and windows are regularly spaced, with double hung sash, 12x12 panes. The side has a central, big composed window, with two windows on each side. Lintels and sills are of soft stone, with no decorative detailing. There are no hints about the appearance of the original first floor, but is reasonable to assume it had the same unpretentious simple forms linked to Adam or Georgian style. Currently the first floor has a classic entablature that supports a wrap-around cornice, and a false roof eave, covered with copper plate. The cornice is quite elaborate, with brackets and dentils. The main entrance, on the Central Avenue side, has wide paneled windows flanked by pairs of Corinthian pilasters, while the other side has two wide windows, at the extremes, and blind red brick wall in the center.

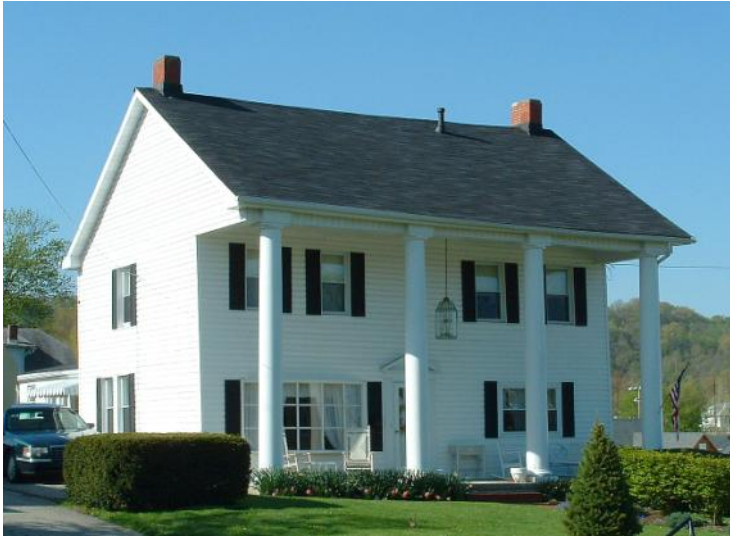
Dirton Home

The design of this house is a simpler, stripped-down version of a Greek Revival romantic house, in fashion from 1825 to 1860. It has a full façade porch, supported by four Doric columns. There is no entablature, as the eaves of the side gabled roof are right above the columns. The main entrance is simple as well, only marked by a pedimented frontispiece and an architrave trim. The house is made of timber, and walls are clad with drop horizontal boards.

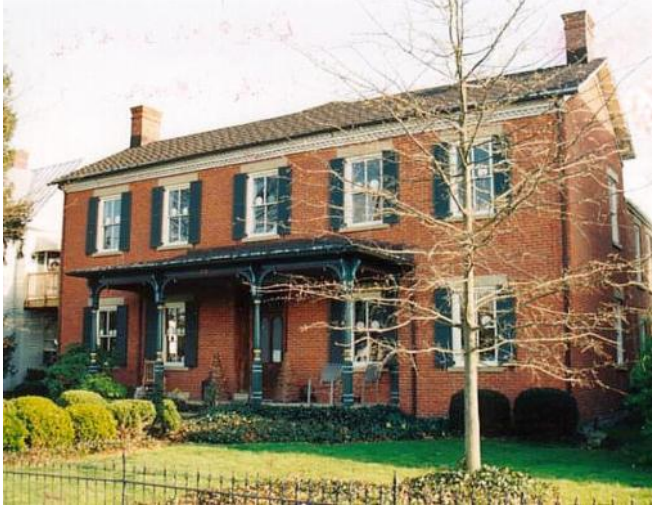
5 William Clendenin Miller House

This example of Federal style, fashionable in most of the United States until 1830, is a late, simpler version (1852), found in West Virginia, a region only recently settled at that time.

It is a simple rectangular block, with five bays of windows, aligned horizontally and vertically in symmetrical rows. The main doorway is a small, hooded entrance, with brick surrounds. It has a wood porch supported by four molded columns that protect three of the bays. The moldings and brackets that support the beams have been delicately crafted. Windows are all equal, and have a flat stone lintel, and a thin sill. They are single-hung, 2x2, and have Venetian shutters. The walls are all of coursed red brick, and the roof-wall junction is also made of brick, with rows of advancing diagonal coursed bricks which mimic the tooth dentils of a classical entablature.

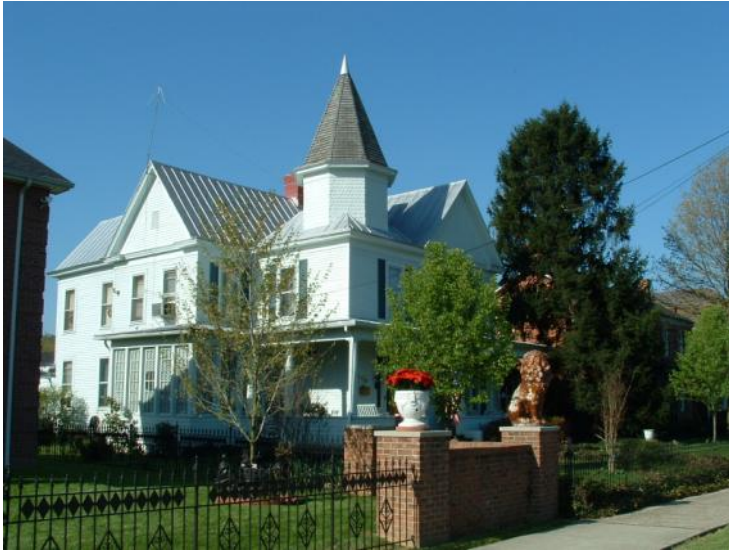
6 George McComas House

This house is a ... eight room dwelling, with asymmetrical plan, irregular massing of components, exhibits several combinations of building forms and decorations. The front facing, rear facing gabled tin roof contains boxed cornices and a pronounced fascia. The roof of the porch follows the same pattern. The front facing gables as well as the turret are covered with fish scale shingles. The roof of the turret is tent shaped with an octagonal base. The exterior of the structure has been covered with aluminium siding of a horizontal weatherboard design, consistent with the original wooden weatherboard design.

A wrap around veranda, typical of Queen Anne statement, is covered by a tin roof supported by a tin roof supported by relatively new Doric columns. A wrought iron fence surrounds the structure. (2).

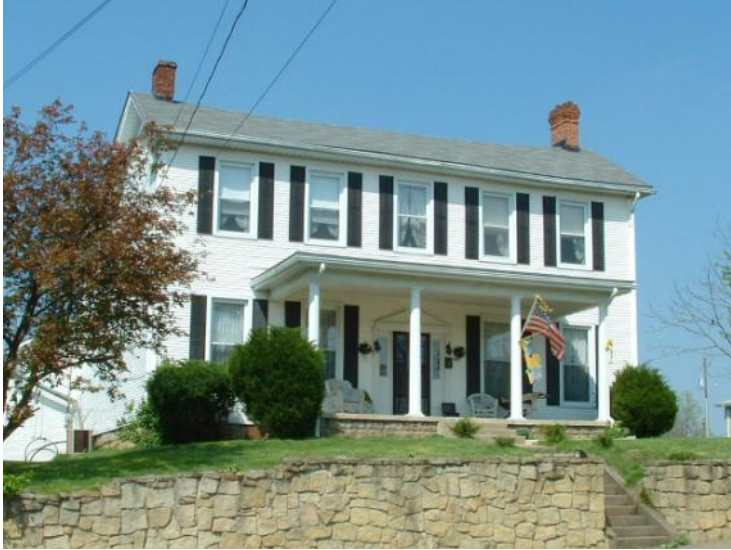
Miller Stowasser House

Another old example, which has several traits of Federal Style (or Adam style): a side gabled building; two floors, with gentle pitched roof; odd number of window bays; double hung sashes, in this case 5, with louvered shutters; and a three bays portico that protect the entrance. However, this is even a simpler example, since it lack the usual cornices.

Since window panes and muntins are easily modified, current windows have 1x1, but probably the original windows were 6x6. As this building was built before the arrival of the railroad line, its structure is of 12 feet by 12 feet, hand hewn oak beams.

A classical portico brings a shelter near the entrance, supported by four thin, classical columns, and a flat entablature. The main doorway has a pedimented frontispiece and two sidelights.

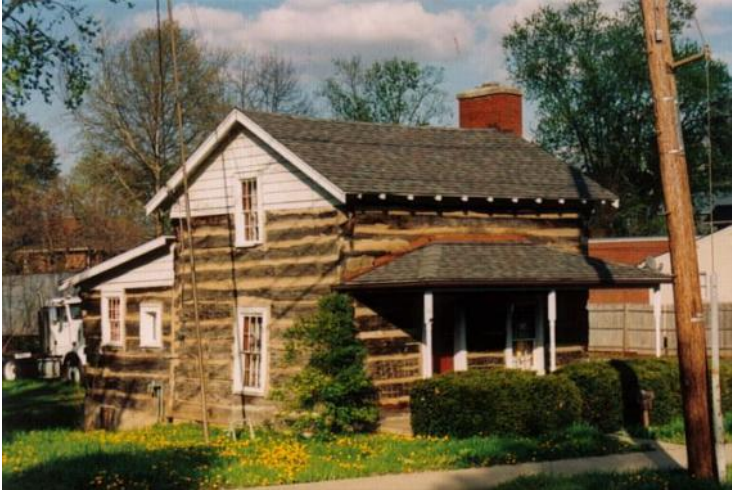
8 Old Toll House

Architecturally and historically, this structure is significant in that it is one of the few original log buildings left in the area that dates from the 1830's.

This log-house is a typical midland pre-railroad building, and this one was at the side of a toll road, (and later moved to its present location), when the chief manner of surface transportation was by horse drawn wagons. The interior is divided in two rooms (hall and parlor) by stairs, with a chimney at the right side. It has an added shed porch, supported by thin molded wood poles. At the back stands single-story addition. Windows have double hung sash, with 6x6 panes.

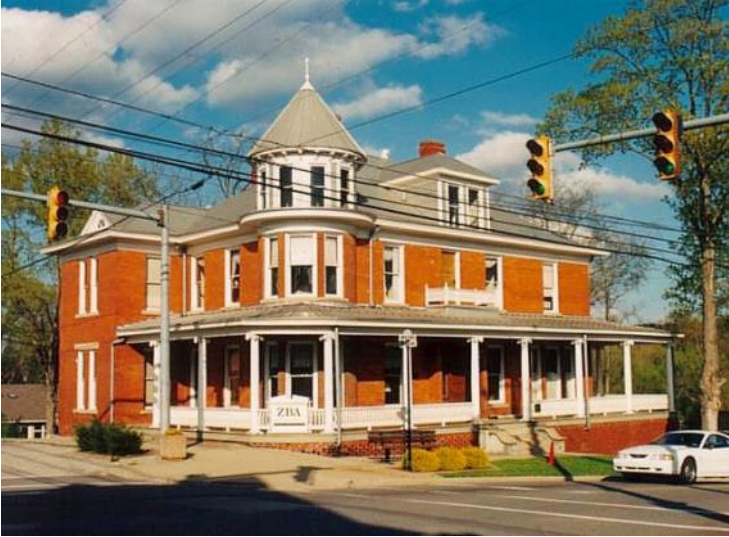
9 George Thornburg House

It is an excellent example of the Queen Anne style. Built of red brick and boasting a tower with conical roof, the house is graced by a wrap around porch and an abundance of ornamental detailing. (4)

The Queen Anne style often features a cylindrical tower topped by a conical roof. In this case it is located at the corner of the building, as a turning bolt that resolves the union of the two adjacent façades. Note how the wrap-around cornice runs along the façades and around the tower, echoed by the horizontal edge of the porch. Thus, horizontal and vertical drives are steadily balanced.

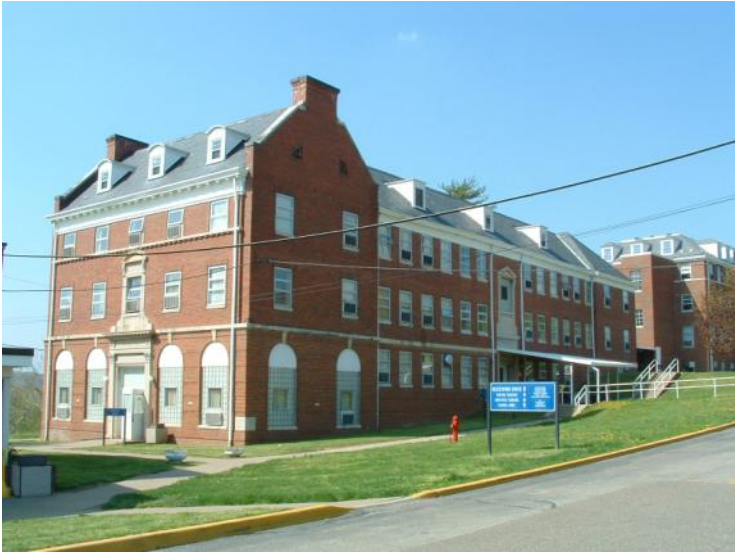
10 Fortification Hill Veterans Home

Most of the buildings have an Eclectic Colonial Revival look, with parapeted gables and doorways with Renaissance frontispieces and other classical detailing and window surrounds.

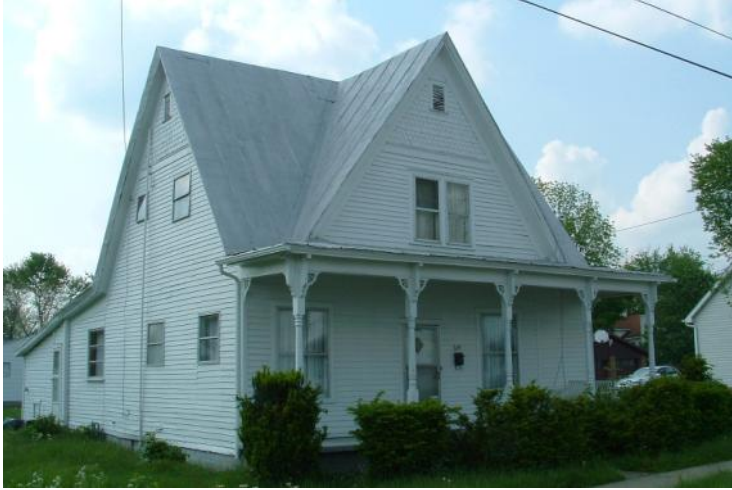
11 James Brown Residence

The actual age of this dwelling is unknown, but the present occupant possesses documents that indicate the house dates to at least 1900. This structure contains elements of Gothic revival, which was popular in the Eastern US in the later 1800.

A unique feature of the dwelling includes one front facing and two end facing high pitched gables, characteristic of Gothic revival. The roof and porch are covered by original metal and the exterior is covered by original clapboard. Fishscale shingles are situated at the apex of the gables. Windows are mid 20th century alterations, two over two replicas. The porch is supported by four decorated columns, topped by a simple undecorated fascia with ornate border brackets and supports. (4)

A beautiful spindlework could be seen in the decorated capitals of the columns. Rare semicircular lace-like brackets adds a note of delicacy to this house.

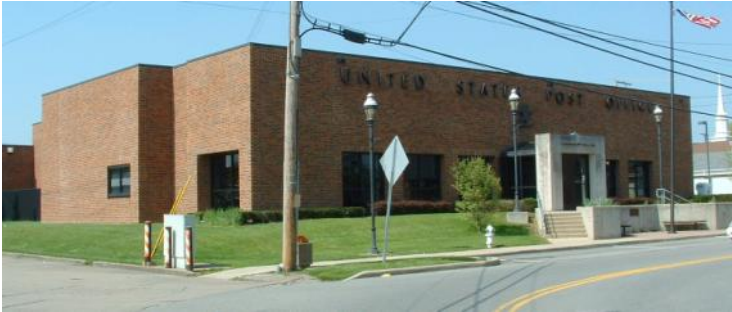
12 U.S. Post Office

The United States Postal Service has designed and built several typical, medium size facilities for small towns like the one in Barboursville. In this case, a simple, bare brick masonry symmetrical box, well proportioned, emphasizes its mass while also making it lighter. Several openings in the ground floor achieves this outcome. A detached portico, made in concrete, protects the entrance.
